NASA CR-120518

CHARACTERIZATION OF EXOTHERMIC BRAZING COMPONENTS
SKYLAB EXPERIMENT M552

By H. E. Pattee and R. E. Monroe
Battelle Columbus Laboratories
Columbus, Ohio 43201

December 1973

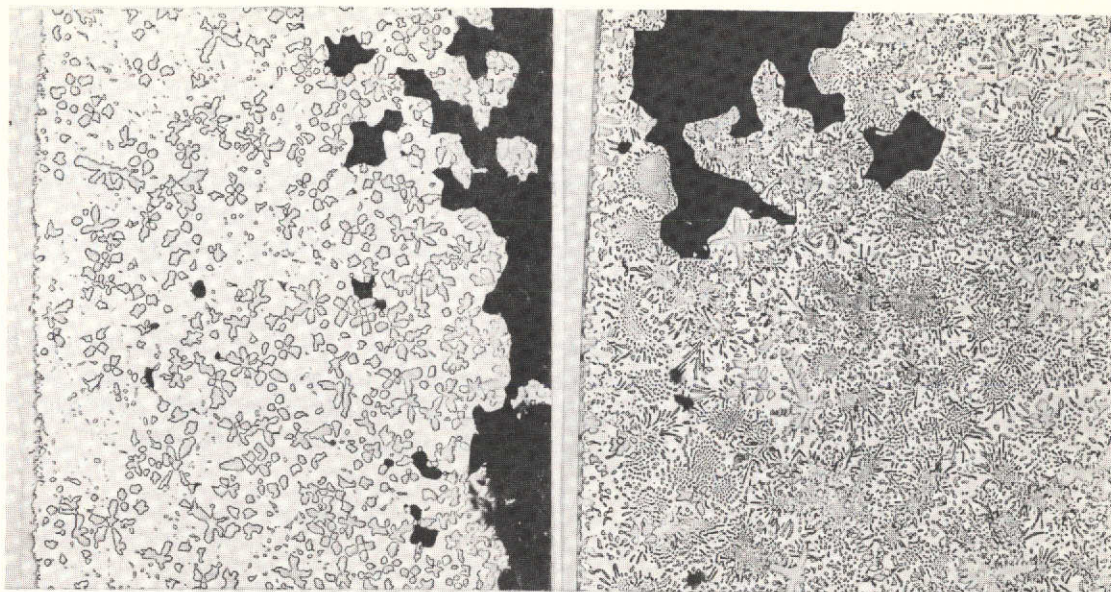
- (1) Specimen SLS-1 (Skylab-stainless steel-0.005 inch gap) was an essentially void-free braze. The microstructure and many other characteristics of this braze were similar to comparable ground-based specimens. Retention of braze alloy in corners of the oversize ring groove and fillet formation in this region was significantly better on the Skylab specimen as shown in Figure 1. This observation clearly supports the enhancement of surface tension forces in a zero gravity field. The tendency for excess braze alloy to collect at low points in the ground-based specimens was completely absent in the Skylab sample. This confirms expectations that braze assembly orientation will have no effect on braze distribution in zero gravity.

FIGURE 1. EFFECT OF ZERO GRAVITY ON BRAZE ALLOY RETENTION AND
FILLET FORMATION IN RING GROOVE AREAS OF STAINLESS
STEEL BRAZES

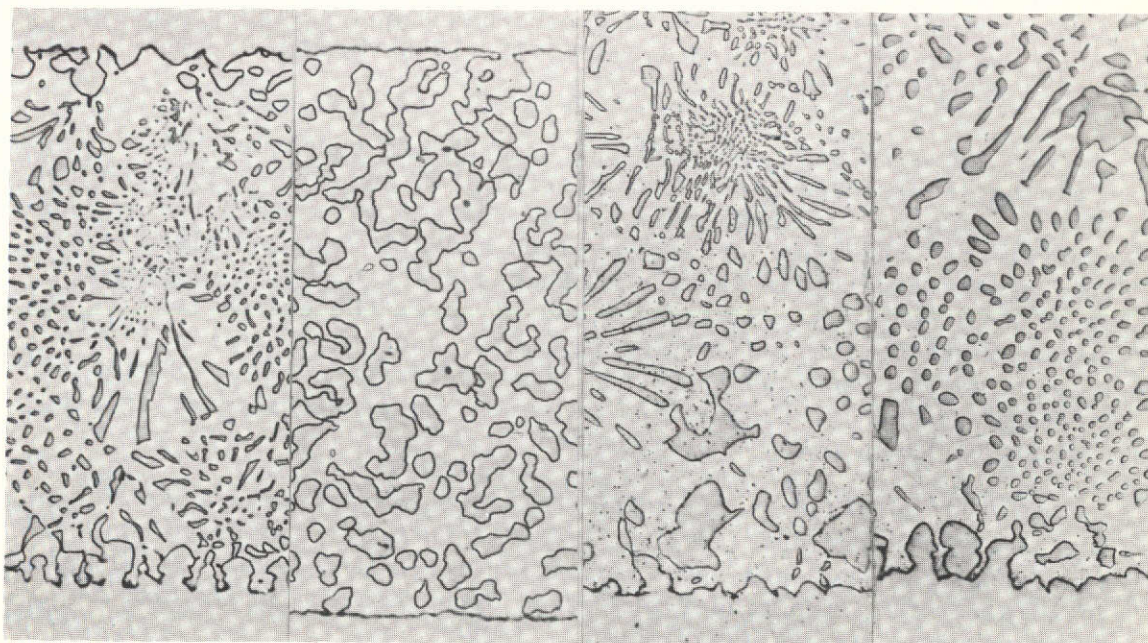
- (2) Specimen SLN-2 (Skylab-nickel-0.010 inch gap) contained minor voids comparable to the ground-based specimens. The microstructure of the braze alloy in this specimen varied with location and was frequently different from the structure exhibited by ground-based specimens as shown in Figure 2. The resulting microstructures clearly indicate variations in the braze alloy composition and perhaps some variation in the cooling rate. However, there is no obvious relation to an effect of the zero gravity environment. Observations of braze alloy retention and fillets in the ring groove area and the location of excess alloy in the nickel specimens further supports the conclusions given above about surface tension forces and orientation effects.

FIGURE 2. COMPARISON OF MICROSTRUCTURES IN SKYLAP AND GROUND BASED NICKEL BRAZE SPECIMENS

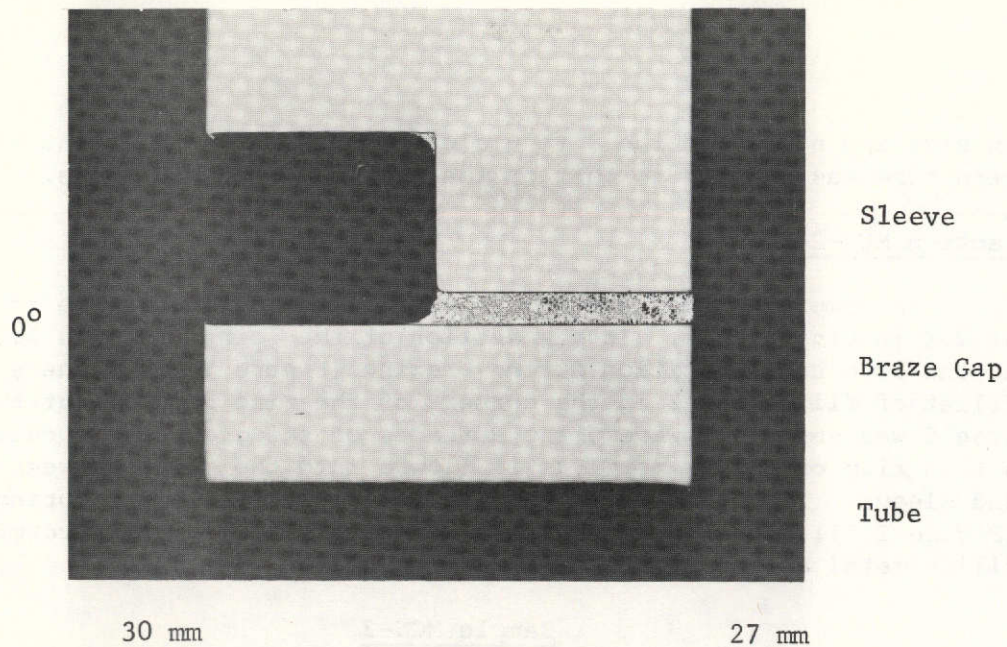
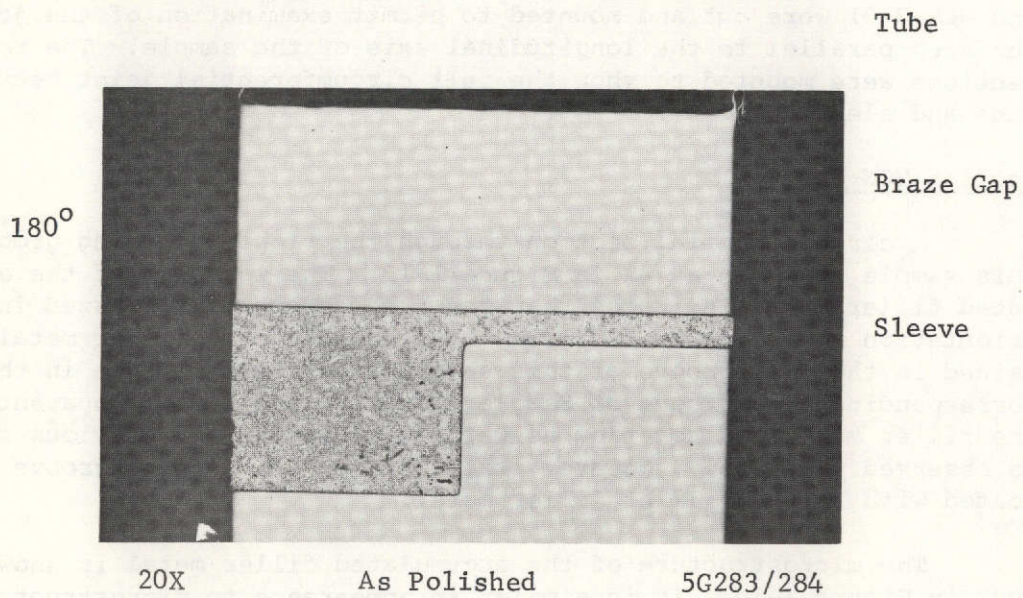
The cross section of the right-hand ring groove was also examined. In appearance, this cross section was essentially identical to that shown in Figures I-11a and I-11b. The lower portion of the ring groove was filled with filler metal; the upper portion was empty. However, filler metal had flowed from the ring groove to fill the joint between the tube and sleeve.

FIGURE I-11. APPEARANCE OF RING GROOVE AREA SHOWING ALLOY FLOW TO LOW POINT - SECTION MCN-2.9 (27 to 30 mm)

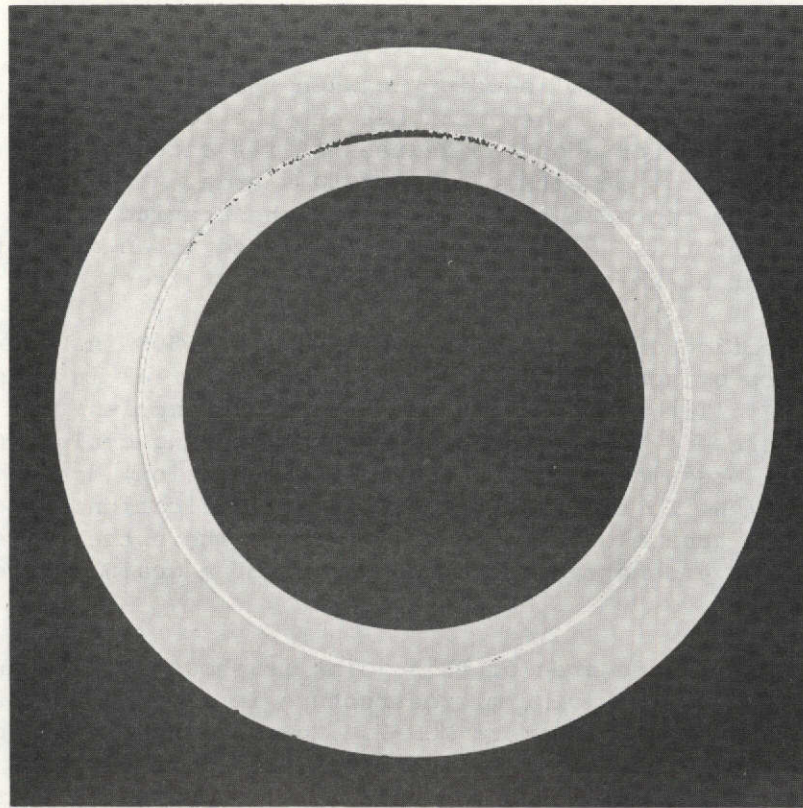
A circumferential section between the ring grooves is shown at 4X in Figure I-15. The joint between the tube and the sleeve is essentially void for about 40 degrees of its circumference, and there are numerous voids on either side of this area. The void area was located at the top of the sample during the brazing cycle. In the radiographs of this joint, it was interpreted as an area of porosity. The remainder of this joint was largely defect-free.

A section of the void area is shown at 250X in Figure I-16. The presence of some filler metal and some material in a zone where the molten filler reacted with the base metal implies that filler metal was present in this area during the brazing cycle. However, much of it (presumably of the eutectic composition) drained into areas deficient in filler metal before solidification was completed. There is one area along the lower interface where the filler metal appears to have penetrated the boundaries of a grain in the base metal.

FIGURE I-16. SECTION MCN-3.4 SHOWING LARGE SHRINKAGE VOID AREA

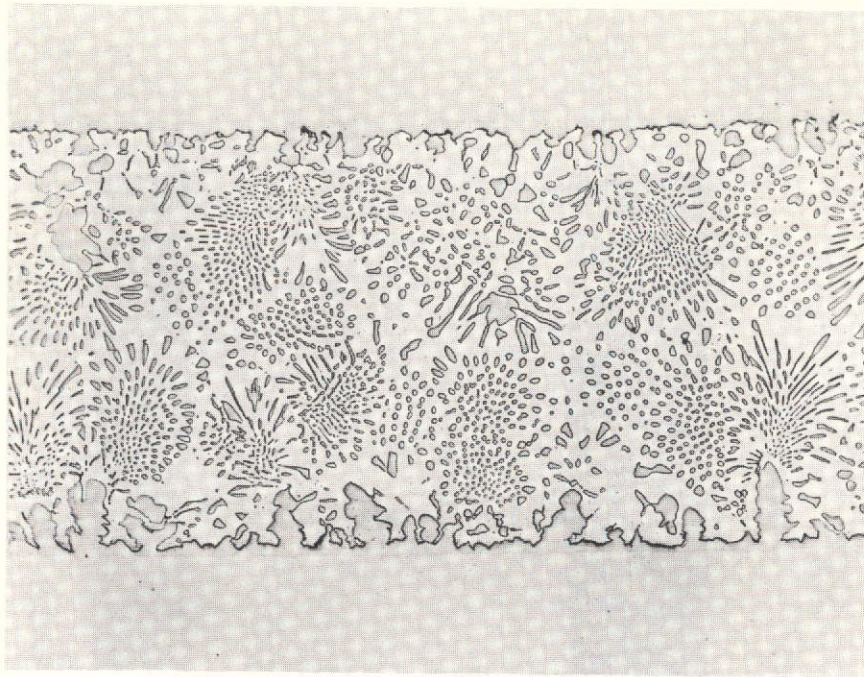
A defect-free area of this joint is shown at 250X and 500X in Figure I-17. The joint microstructure is similar to that observed in various sections of Sample MCN-2. However, the length of the particles along the interface indicates that more reaction between the molten filler metal and the base metal occurred in this sample than in Sample MCN-2.

FIGURE I-17. MICROSTRUCTURE IN SECTION MCN-3.4 (15 mm)

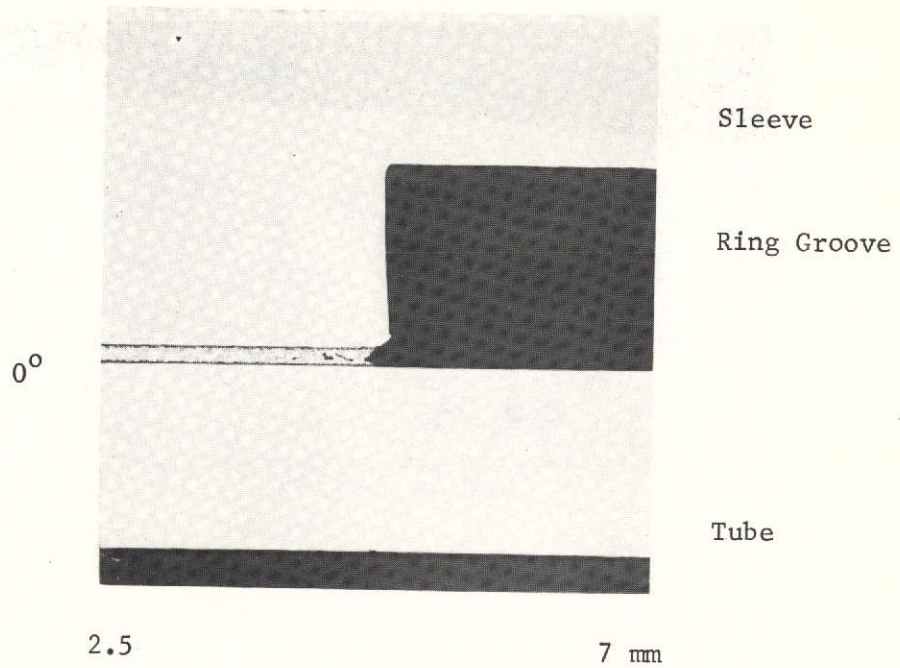
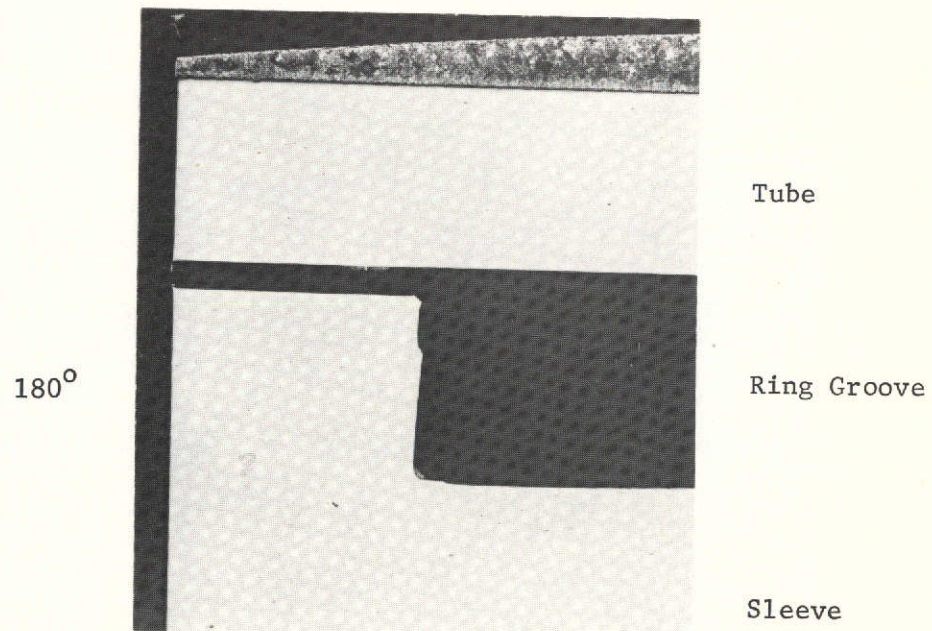
The upper and lower portions of the section adjacent to the one discussed above (MCS-1-1) are shown at 20X in Figures II-5; this section contains the filler metal ring groove and a short length of tube-to-sleeve joint. The ring groove is devoid of filler metal; however, there was evidence of a very thin film of filler metal on the ring groove surfaces at high magnification. As in the previous section (and as indicated by radiography), the upper section of the joint was filled with filler metal; the lower section was void. Filler metal is puddled at the bottom inside of the tube. This filler flowed from the ring groove to the center of the sample, through the slits in the tube, and back along the inside of the tube.

FIGURE II-5. APPEARANCE OF GAP AND RING GROOVE -
SECTION MCS-1.2 (2.5 - 7 mm)

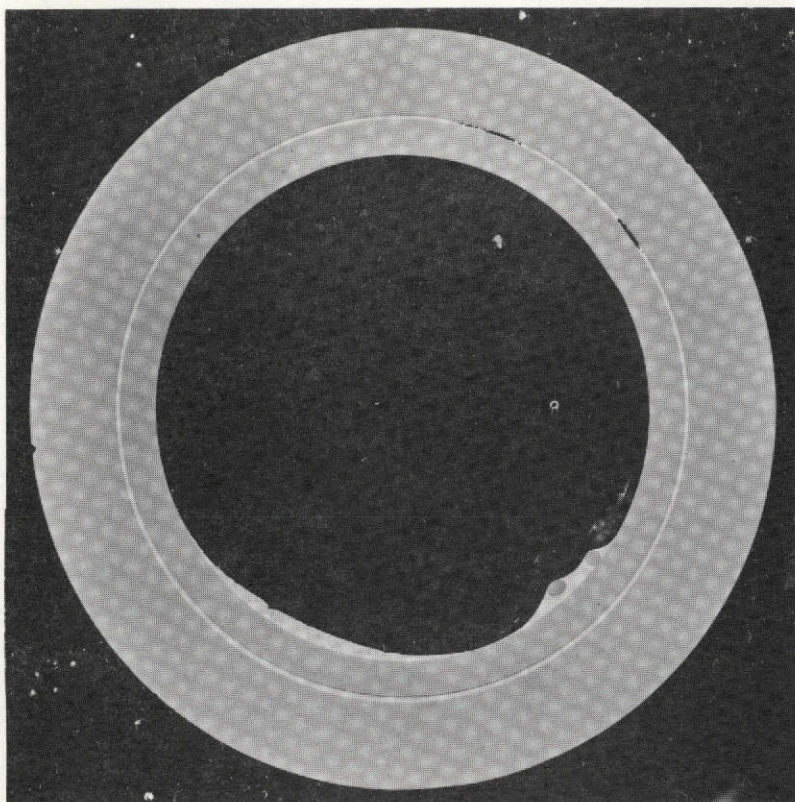
FIGURE II-8. SHRINKAGE VOIDS IN SECTION MCS-1.4 (15 mm)

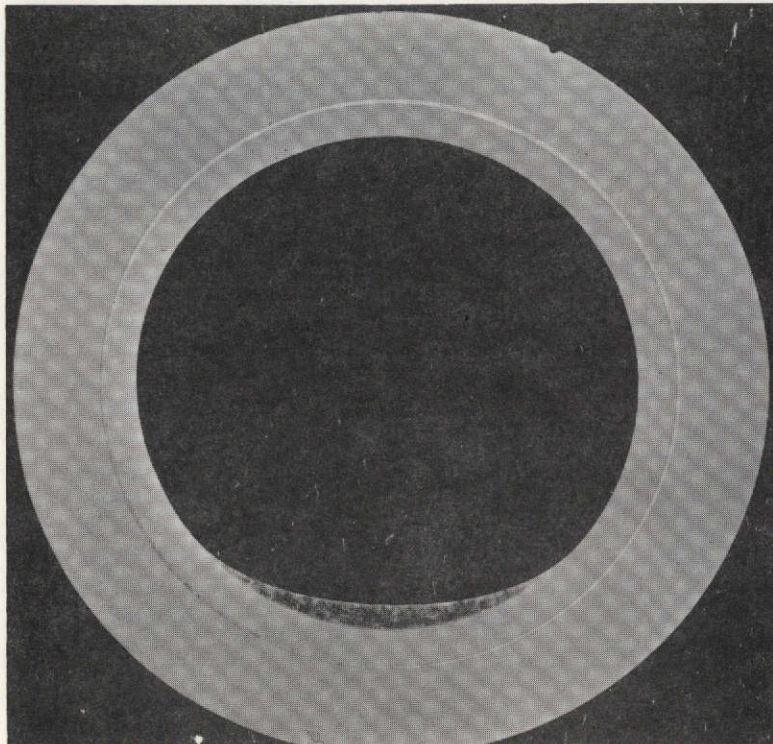
The full circumferential joint between the tube and sleeve is shown at 4X in Figure II-13. The joint quality was excellent and there

FIGURE II-13. CROSS SECTION MCS-2.5 (15 mm)

were no void areas of significance. A section of this joint is shown in the unetched condition at 250X in Figure II-14a; the same section is shown etched in Figure II-14b. The joint microstructure appears similar to those observed in sections from Sample MCS-1.

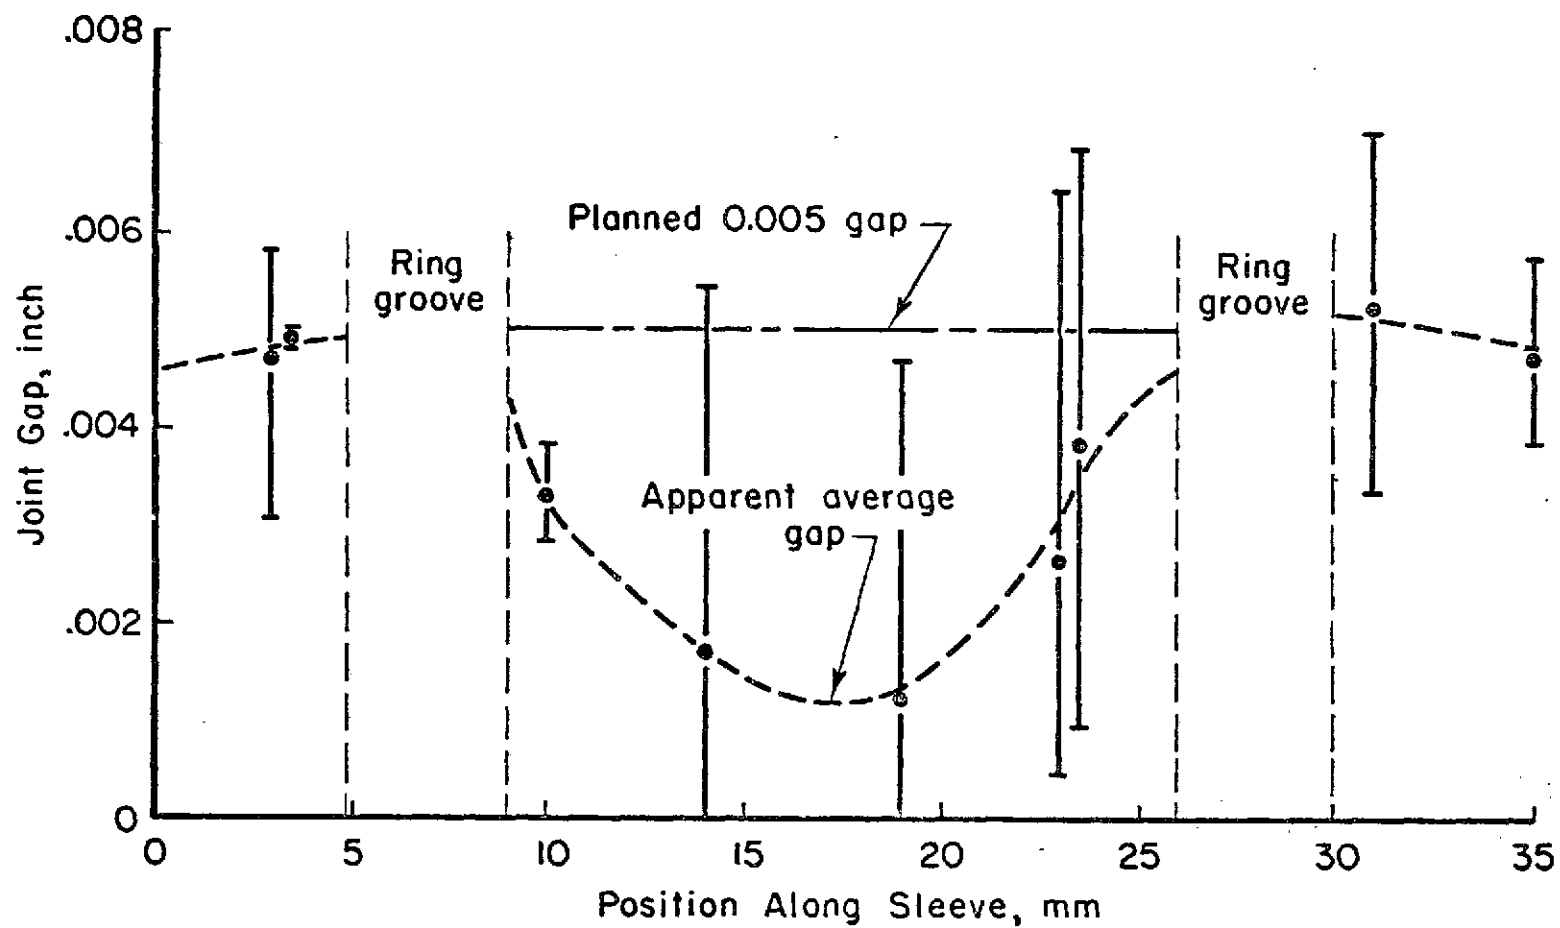
Measurements of both the joint gap and diameters at various points were made in attempts to resolve the gap variations observed. The joint gap measurements are shown in Table III-2. The measured gap ranged from 0 to a maximum of 0.007 in., with most measurements being less than the intended 0.005-in. gap. Average gaps at each sectioning plane are plotted in Figure III-9, to better illustrate this variation. Diameter measurements of individual sections indicated some minor out of round conditions, but were not helpful in establishing the basic cause of the gap variations.

FIGURE III-9. PLOT OF JOINT GAP MEASUREMENTS

Discussion with other investigators, and dimensional checks made at MSFC, suggest that the ends of the tube may have been restrained by the container used to hold the specimens. Such restraint would prevent free thermal expansion of the tube axially and would produce some radial upset.

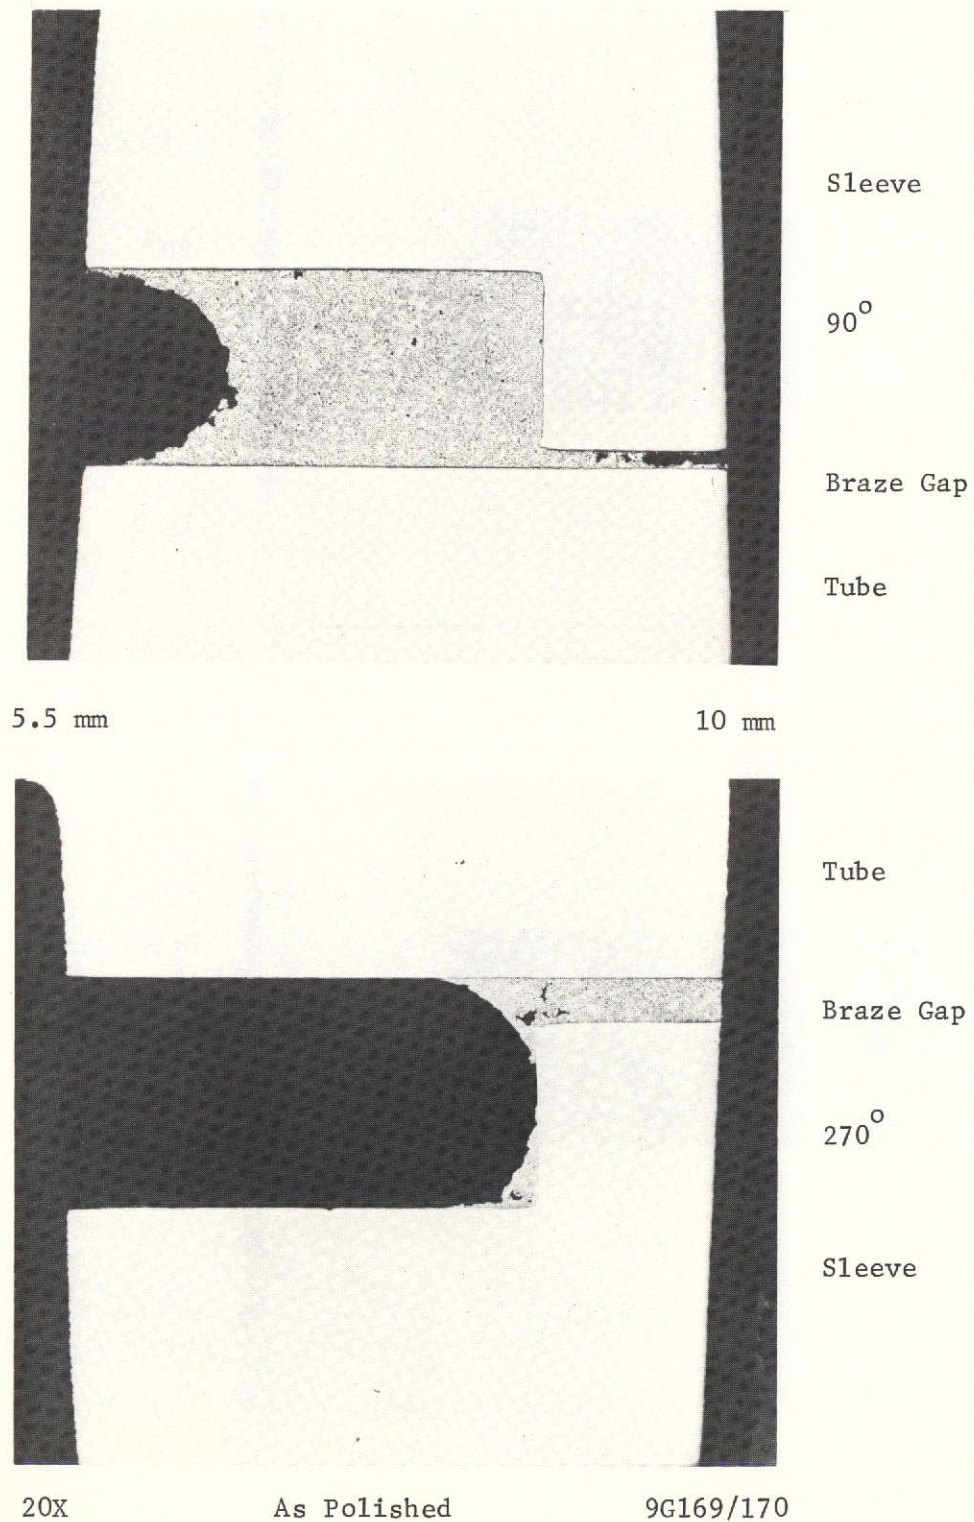
FIGURE III-11. SECTION SLN-2.5.1 (5.5 to 10 mm and 90 and 270°) SHOWING MENISCUS SHAPE AND VOID AREAS AROUND IGNITER END RING GROOVE

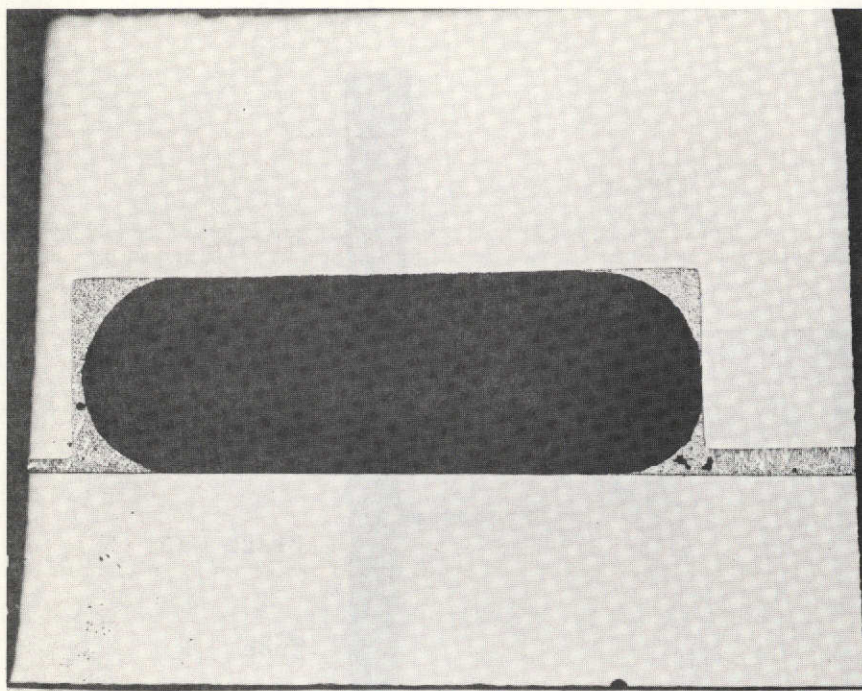
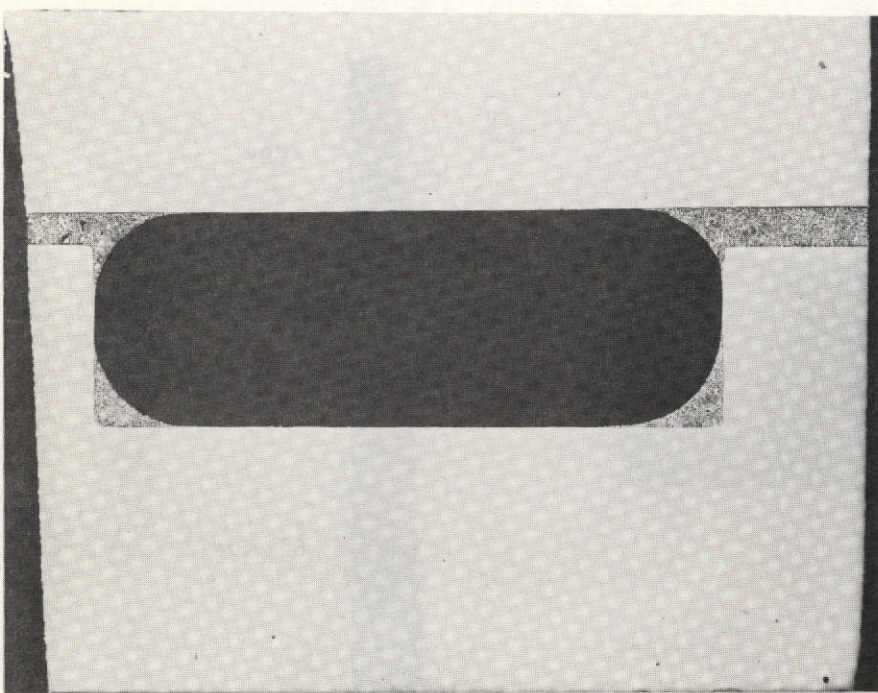
FIGURE III-12. SECTION SLN-2.9.1 (25.5 to 31 mm and 90 and 270°)
SHOWING FILLETS IN RING GROOVE OPPOSITE IGNITED END

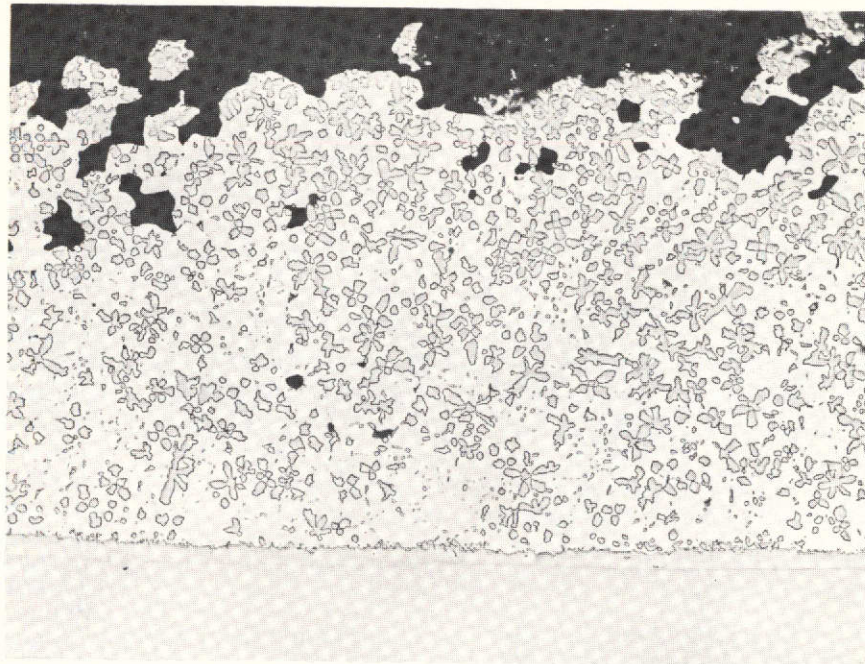
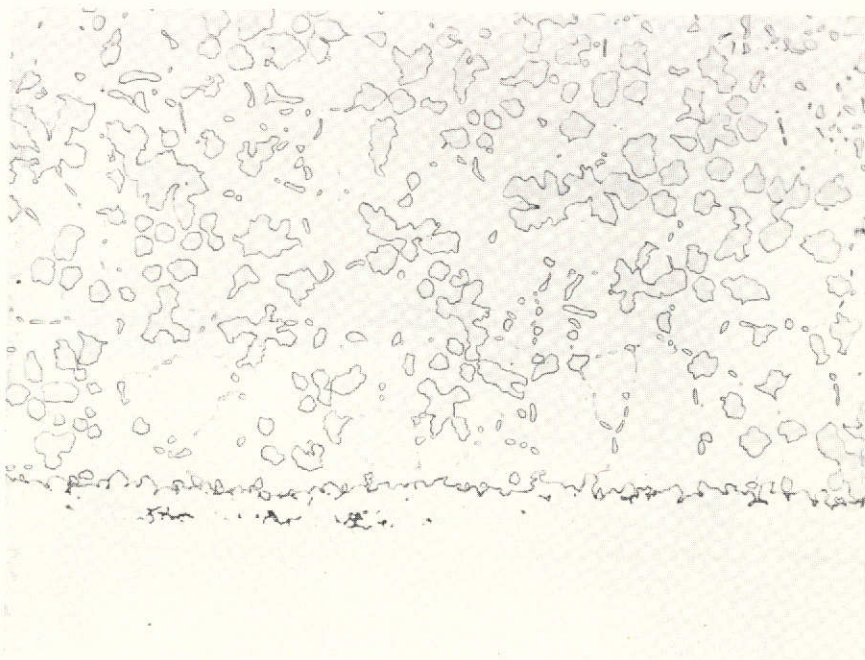
FIGURE III-14. MICROSTRUCTURE OF BRAZE IN RING GROOVE SHOWING COARSE COPPER-NICKEL PHASE AND WIDE DIFFUSION ZONE (SLN-2.4 - 5 mm)

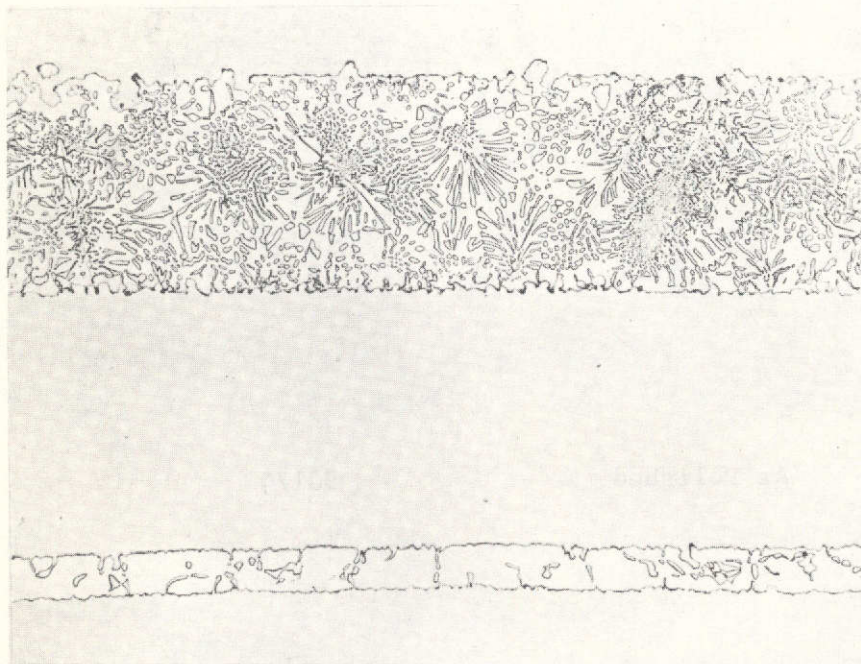
FIGURE III-15. SECTION SLN-2.10 (35 mm) SHOWING VARIATION IN BRAZE MICROSTRUCTURES
